K-637

White Plains Near Massey 2nd Quarter 19th Century

K-637 White Plains

Maryland Historical Trust State Historic Sites Inventory Form

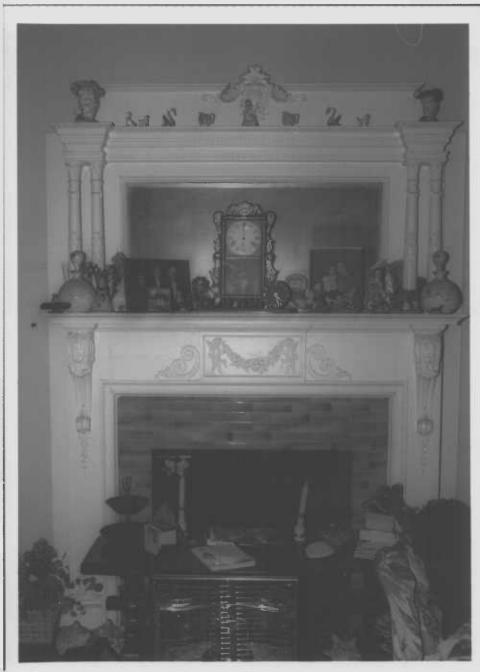
K-637
White Plains
Rt. 313, near Massey
M. Q. Fallaw - 7/3/86
View to southeast horth

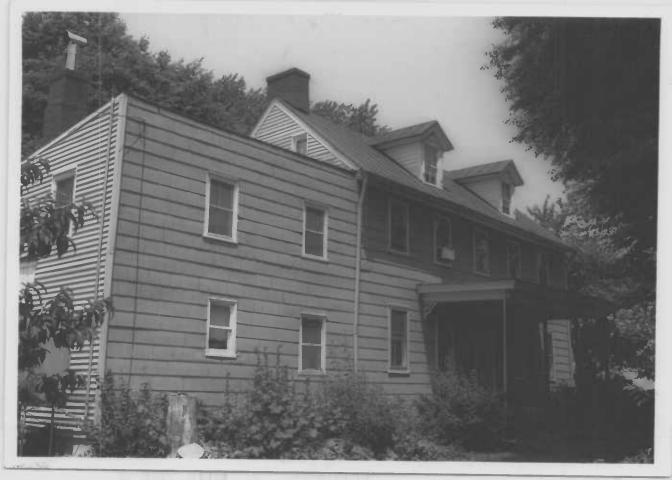
K-637 White Plains Rt. 313, near Massey M. Q. Fallaw - 7/3/86 View to northwest
